TECHNICAL REPORT REMR-CO-3

**CASE HISTORIES OF CORPS BREAKWATER
AND JETTY STRUCTURES**

Report 2

SOUTH ATLANTIC DIVISION

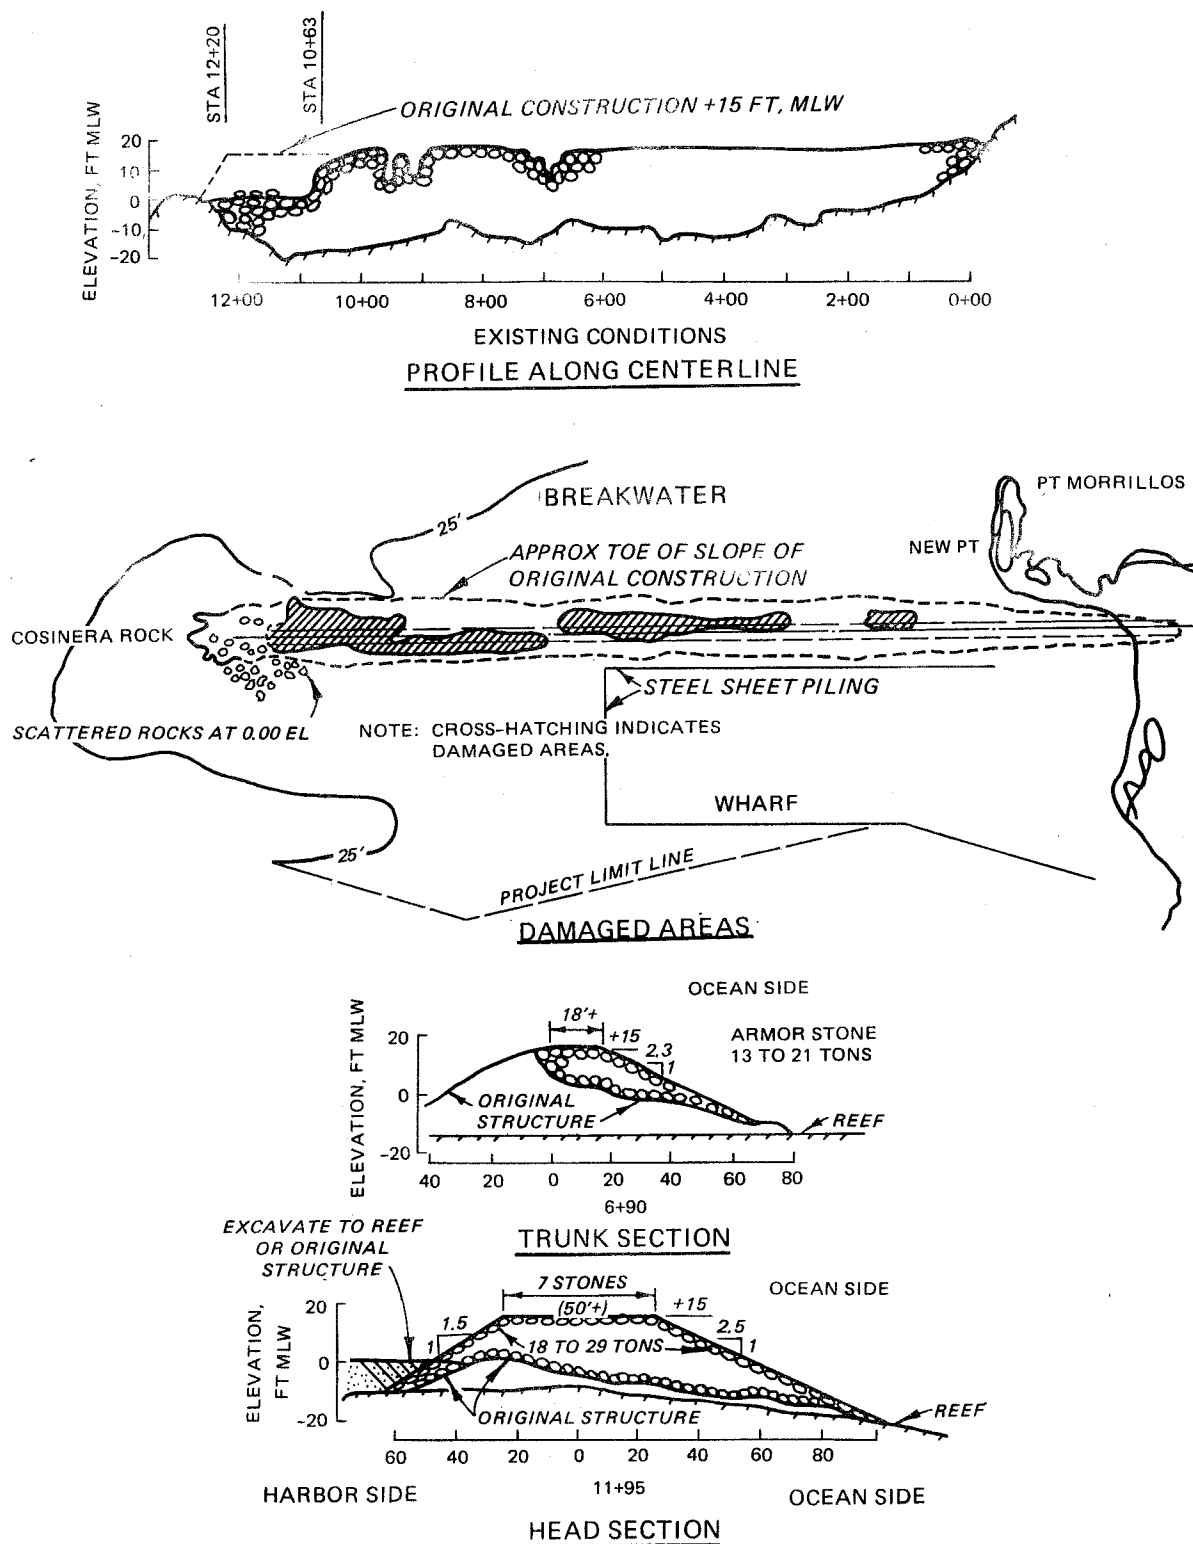
Figure 42. Arecibo Harbor existing damage prior to 1984 repairs and typical repair sections
